LAKE CLASSIFICATION SHORT REPORT ON GOOSE LAKE, ADAMS COUNTY, WI

**Presented by Reesa Evans, Lake Specialist
Adams County Land & Water Conservation Department
P.O. Box 287, Friendship, WI 53934**

AUGUST 2007

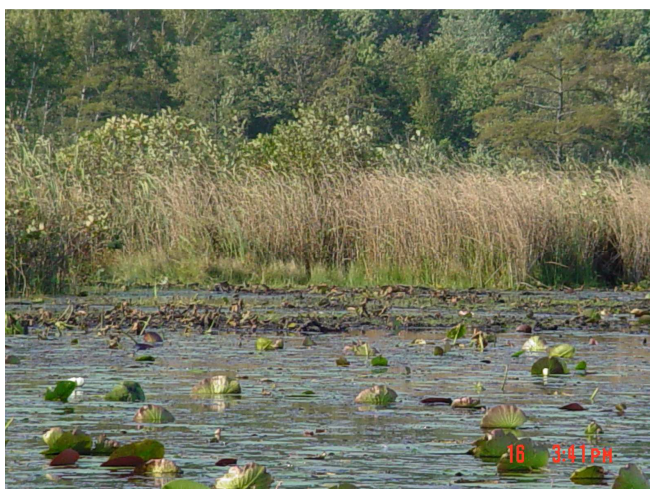
Goose Lake has wetlands around several of its shores, especially along the north shore. Wetlands play an important role in water quality by trapping many pollutants in runoff waters and by serving as buffers to catch and control what would otherwise be uncontrolled water and pollutants. Wetlands also play an essential role in the aquatic food chain, thus affecting fishery, and also serve as spaces for wildlife habitat, wildlife reproduction & nesting, and wildlife food. It is important to preserve these wetlands for the continued health of Goose Lake waters.

**One of Goose
Lake's shoreland
wetlands**

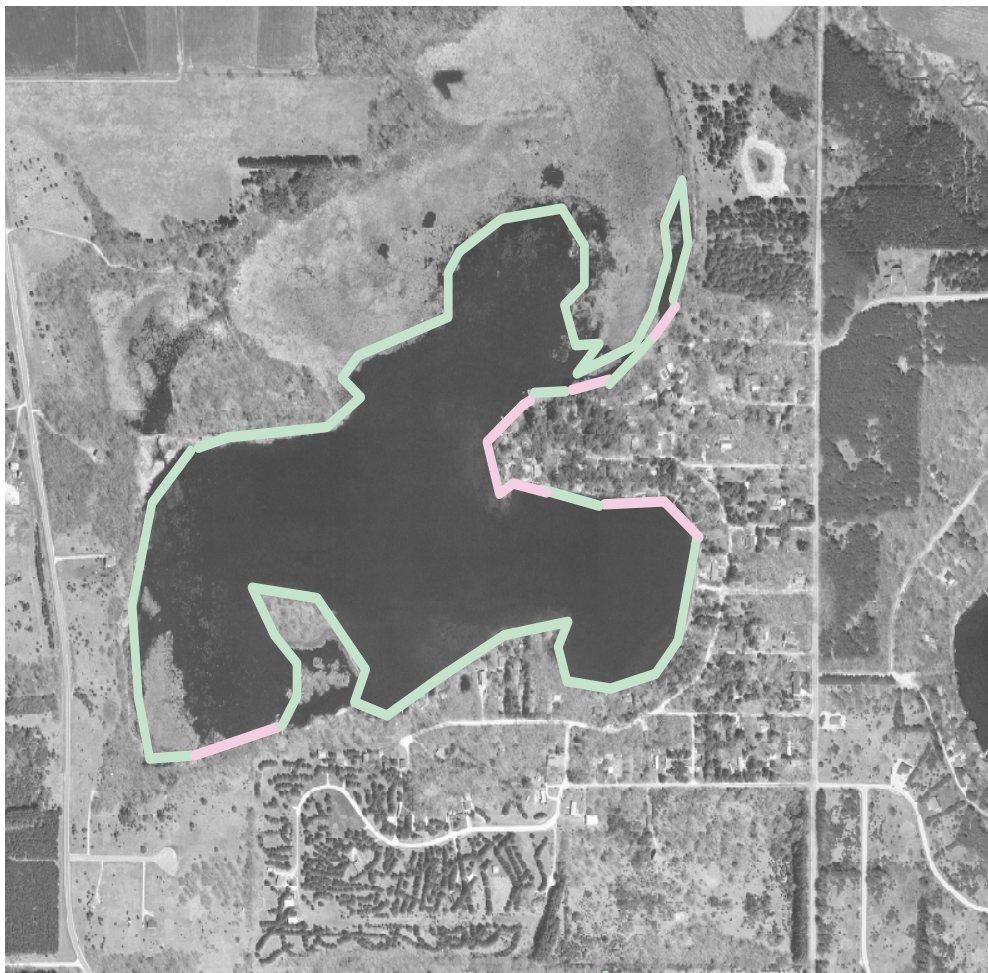
Shoreline--Goose Lake

Goose Lake has a total shoreline of 2.8 miles (14,784 feet). Much of the northern shore has been left unaltered. Included in that area are several wetland types. The rest of the lakeshore is in residential use. Most of the areas near the shore are steeply sloped, while other areas are flatter. Buildings are generally located 70 or more feet back from the shore. A boat ramp owned by the Town of Jackson is located on the east shore of the lake. There is a small beach along each side of the boat ramp area.

Hard Structure/Rock/Seawall

Vegetated Shore

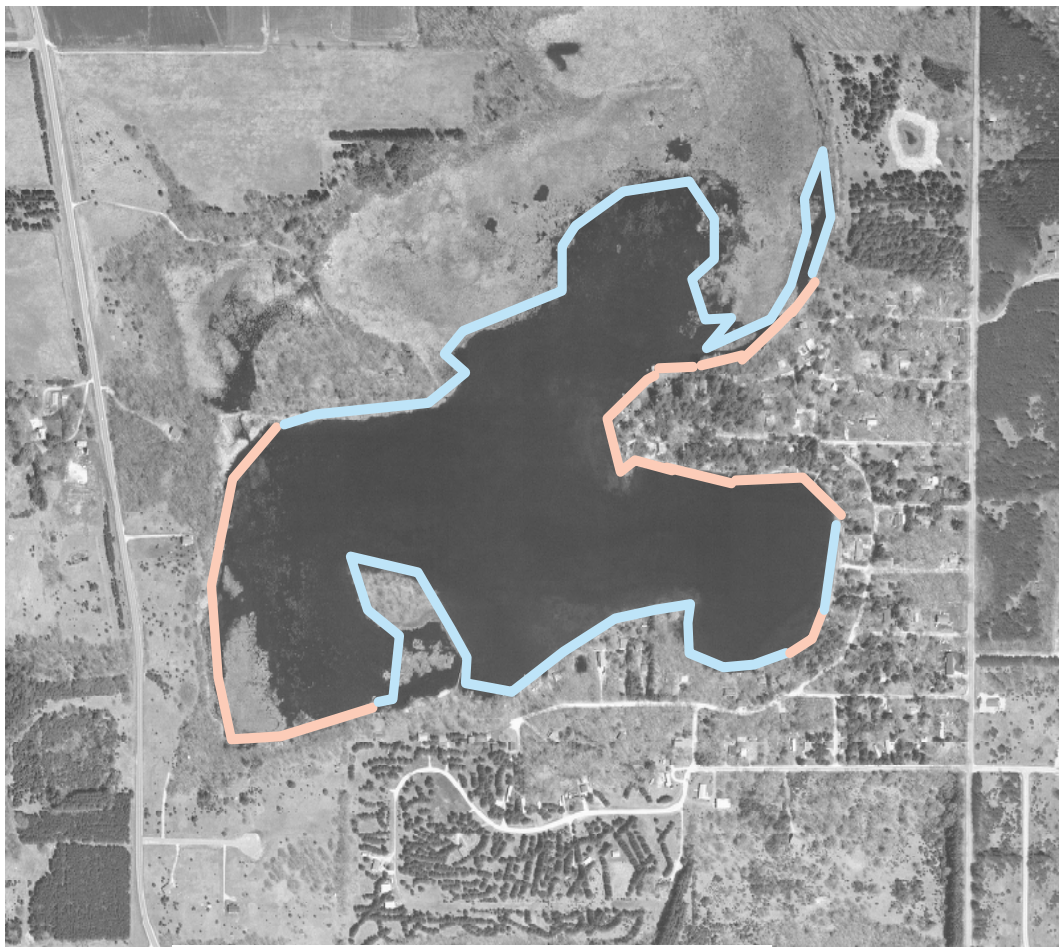
Buffers on Goose Lake

More than three-fourths of Goose Lake's shoreline is vegetated. A 2004 shore survey showed that most of the shore had an "adequate buffer." An "adequate buffer" is a native vegetation strip at least 35 feet landward from the shore. Most of the "inadequate" buffer areas were those with mowed lawns and insufficient native vegetation at the shoreline to cover 35 feet landward from the water line. There were also some shores characterized by hard structures (piers, patios, etc.), rock and/or seawall. The bulk of those without a sufficient buffer were found on the northeast part of the lake, just north & west of the boat ramp. Little of the shoreline had active erosion.

Pink = Inadequate Buffer Blue = Adequate Buffer

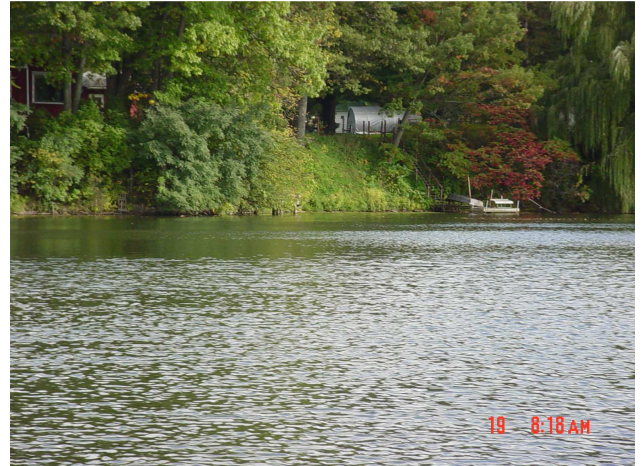
Example of Adequate Buffer

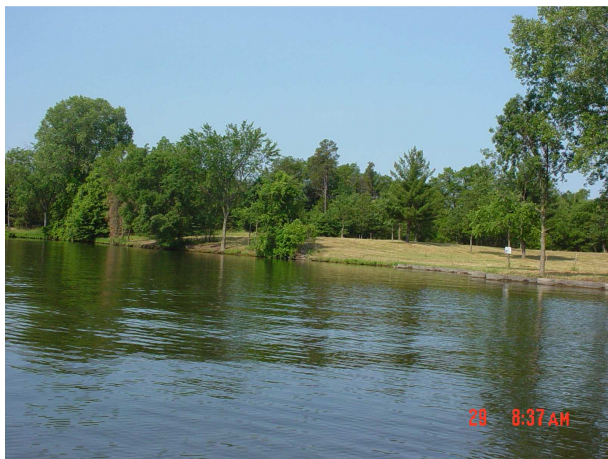
Example of Inadequate Buffer

- Shores with inadequate buffers need to restore the buffers to an adequate condition to provide winter habitat for the weevils, as well to assist in maintaining water quality.

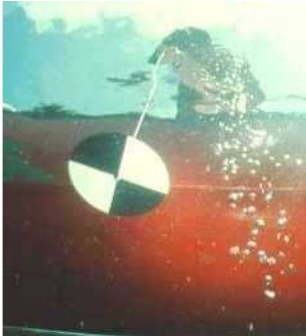
Water clarity readings are usually taken by using a Secchi disk (shown at right). Average summer Secchi disk clarity in Goose Lake in 2004-2006 was 7.1 feet. Water clarity in Goose Lake has consistently remained in the “good” or “very good” clarity category since 1992. Water clarity can be reduced by turbidity (suspended materials such as algae and silt) and dissolved organic chemicals that color or cloud the water.

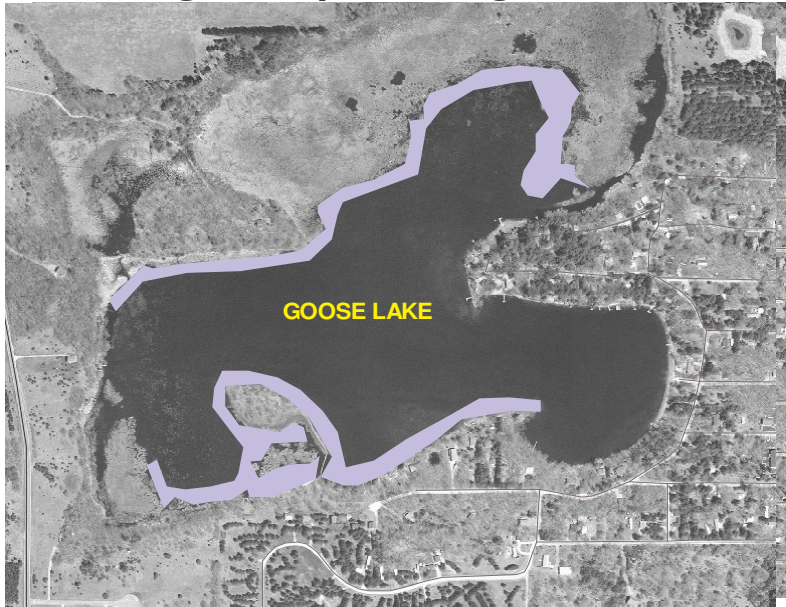
Emergent Aquatic Vegetation

Emergent Vegetation Found

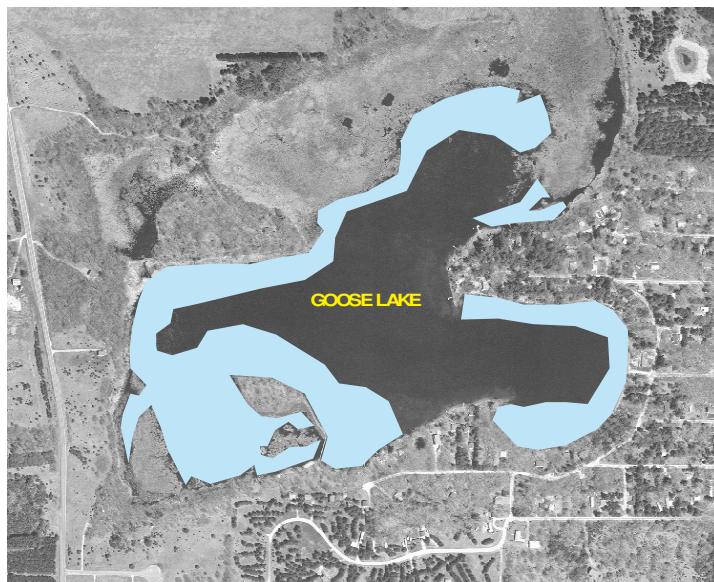
Floating-Leaf Vegetation Found

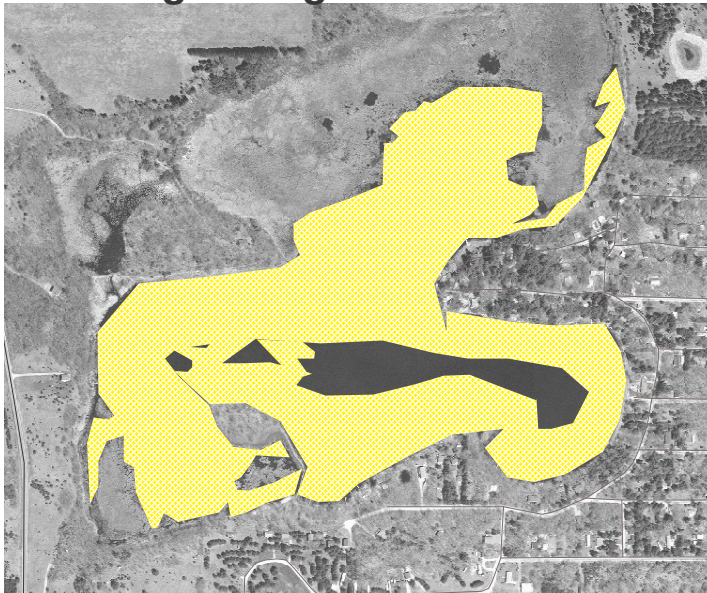
Submergent Vegetation in Goose Lake

Submergent Vegetation Found

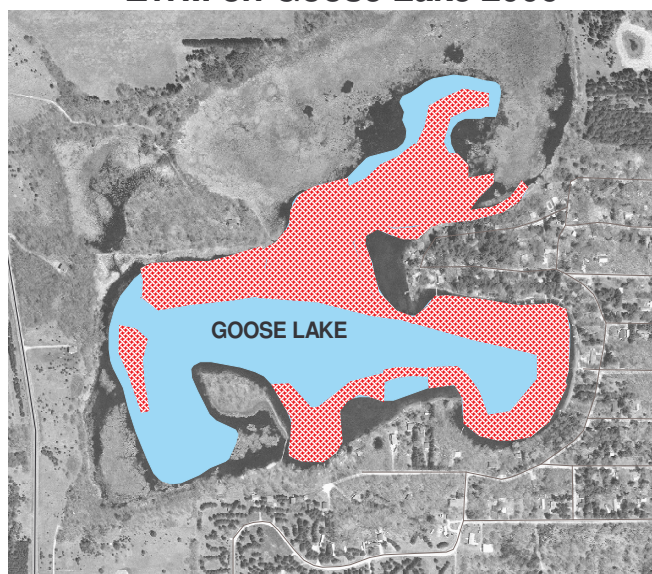
EWM on Goose Lake 2006

Important to maintaining a high quality, diverse aquatic plant community is an integrated aquatic plant management plan that controls the invasive plants in the lake. The most prevalent invasive exotic in Goose Lake is currently *Myriophyllum spicatum* (Eurasian watermilfoil). Other invasive plants found were *Lythrum salicaria* (Purple Loosestrife) and *Phalaris arundinacea* (Reed Canarygrass). These are present, but not common at Goose Lake.

EWM Found

- The Goose Lake Association should maintain exotic species signs at the boat landings and contact WDNR if the signs are missing or damaged.
- The Goose Lake Association should continue monitoring and control of Eurasian Watermilfoil maintain the most effective methods and modify if necessary. The Lake Association should investigate ways to increase treatment effectiveness in the deeper water. Residents may need to hand-pull scattered plants.

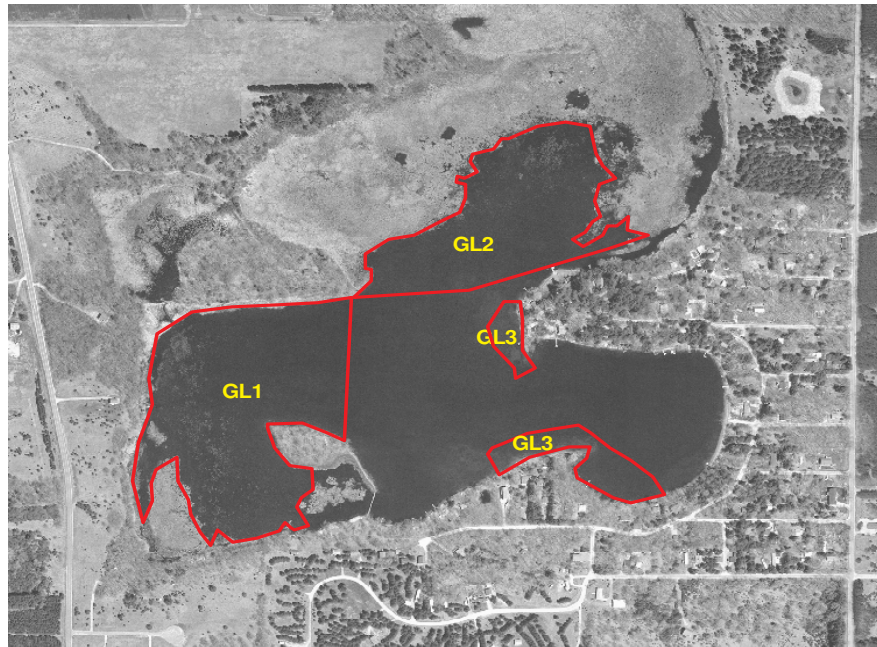
Critical Habitat Areas--Goose Lake

Three areas on Goose Lake were determined to be appropriate for critical habitat designation. GL1 extends comprises the west basin, up to the ordinary high water mark. GL2 extends covers the north basin, mostly a wetland area. GL3 was added in 2006 and cover areas of the west and south shore

- Maintain current habitat for fish and wildlife.
- Investigate availability of areas for northern pike spawning. Increase such sites if necessary to encourage more reproduction of northern pike.
- Leave fallen trees along shoreline & in water. Leave snags & cavity trees for nesting.
- Seasonal protection of spawning habitat.
- Maintain the wildlife corridor.
- Maintain sedge meadow/deep marshes areas.
- Protection emergent vegetation. No alteration of littoral zone except for WDNR-approved projects.
- Seasonal control of exotics. Regular monitoring for presence of exotics.
- No bank grading or grading of adjacent land.
- Maintain aquatic vegetation in undisturbed condition for wildlife habitat, fish use and water quality protection.
- Maintain no-wake zone designations, especially in critical habitat areas.
